HORN SYSTEMS

INTRODUCTION

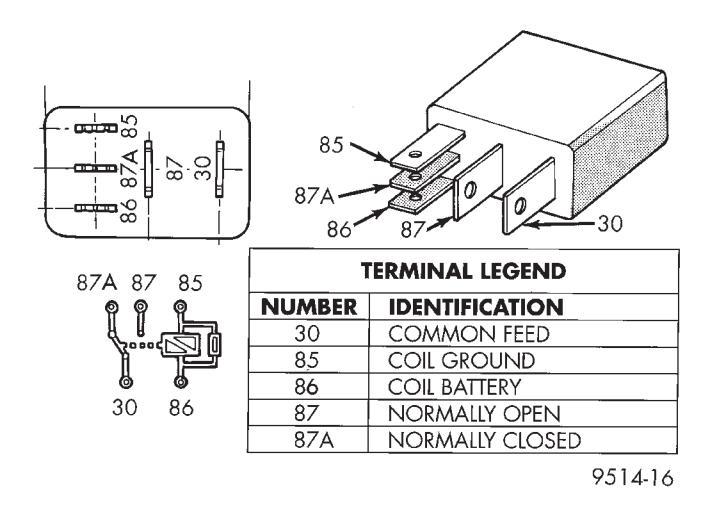
Fig 1. Horn Relay

The horn relay (Fig. 1) is located in the Power Distribution Center (PDC) in the engine compartment. Refer to the PDC label for horn relay identification and location.

(1) A relay in the de-energized position should have continuity between terminals 87A and 30, and

no continuity between terminals 87 and 30. If OK, go to Step 2. If not OK, replace the faulty relay.

(2) Resistance between terminals 85 and 86 (electromagnet) should be 75 \pm 5 ohms. If OK, go to Step 3. If not OK, replace the faulty relay.

(3) Connect a battery to terminals 85 and 86. There should now be continuity between terminals 30 and 87, and no continuity between terminals 87A and 30. If OK, see the Relay Circuit Test in this group. If not OK, replace the faulty relay.

The horn relay is a International Standards Organization (ISO) micro-relay. The terminal designations and functions are the same as a conventional ISO relay. However, the micro-relay terminal orientation (or footprint) is different, current capacity is lower, and the relay case dimensions are smaller than those of the conventional ISO relay.

The horn relay is a electromechanical device that switches battery current to the horn when the horn switch grounds the relay coil. See the Diagnosis and Testing section of this group for more information on the operation of the horn relay.

(1) The relay common feed terminal cavity (30) is connected to battery voltage and should be hot at all times. If OK, go to Step 2. If not OK, repair the open circuit to the PDC fuse as required.

(2) The relay normally closed terminal (87A) is connected to terminal 30 in the de-energized position, but is not used for this application. Go to Step 3.

(3) The relay normally open terminal (87) is connected to the common feed terminal (30) in the energized position. This terminal supplies battery voltage to the horn(s). There should be continuity between the cavity for relay terminal 87 and the horn relay output circuit cavity of each horn wire harness connector at all times. If OK, go to Step 4. If not OK, repair the open circuit to the horn(s) as required.

(4) The coil battery terminal (86) is connected to the electromagnet in the relay. It is connected to battery voltage and should be hot at all times. Check for battery voltage at the cavity for relay terminal 86. If OK, go to Step 5. If not OK, repair the open circuit to the PDC fuse as required.

(5) The coil ground terminal (85) is connected to the electromagnet in the relay. It is grounded through the horn switch when the horn switch is depressed. It can also be grounded by the Body Control Module (BCM) in response to inputs from the Vehicle Theft Security System (VTSS) or the Remote Keyless Entry (RKE) system. Check for continuity to

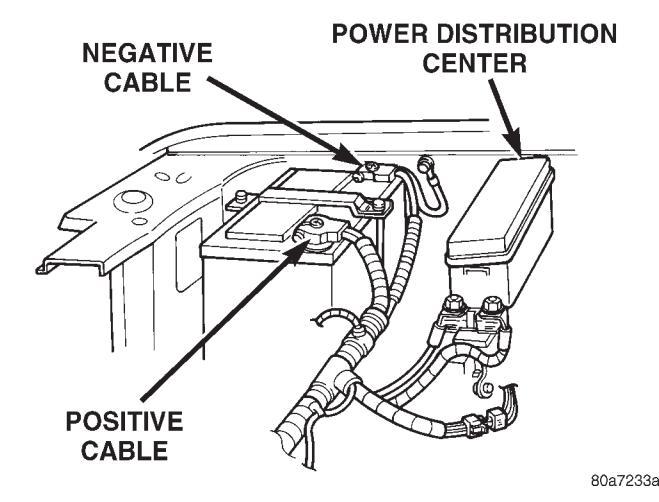
Fig. 2 Power Distribution Center

(2) Remove the cover from the Power Distribution Center (PDC) (Fig. 2).

(3) Refer to the label on the PDC for horn relay identification and location.

(4) Unplug the horn relay from the PDC.

(5) Install the horn relay by aligning the relay terminals with the cavities in the PDC and pushing the relay firmly into place.

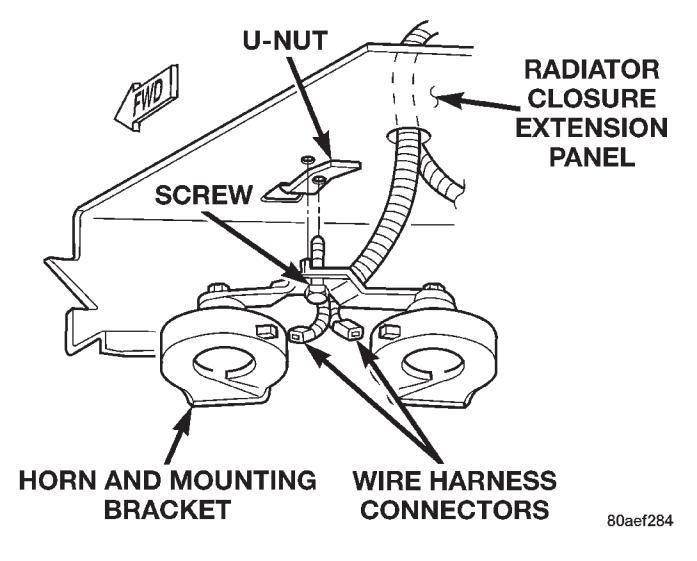
Fig. 3 Horns Remove/Install

(4) Unplug the wire harness connectors from the horns (Fig. 3).

(5) Remove the screw that secures the horn mounting bracket to the radiator closure extension panel.

(6) Remove the horns and mounting bracket from the vehicle.

(7) Reverse the removal procedures to install. Tighten the horn mounting bracket screw to $28 \text{ N} \cdot \text{m}$ (250 in. lbs.).

Dual-note, electromagnetic diaphragm-type horns are standard equipment on this model. The horns are secured next to each other on a bracket beneath the right radiator closure extension panel and forward of the right front inner wheelhouse.

The horns are connected in parallel. Both horns are grounded through their wire harness connector and circuit to an eyelet bolted to the right inner fender shield near the Power Distribution Center (PDC), and they receive battery feed through the closed contacts of the horn relay.
